STM32F100xC, STM32F100xD, STM32F100xE errata sheet

STM32F100xx high-density
value line device limitations

This errata sheet applies to the revision A of the STMicroelectronics high-density value line products.

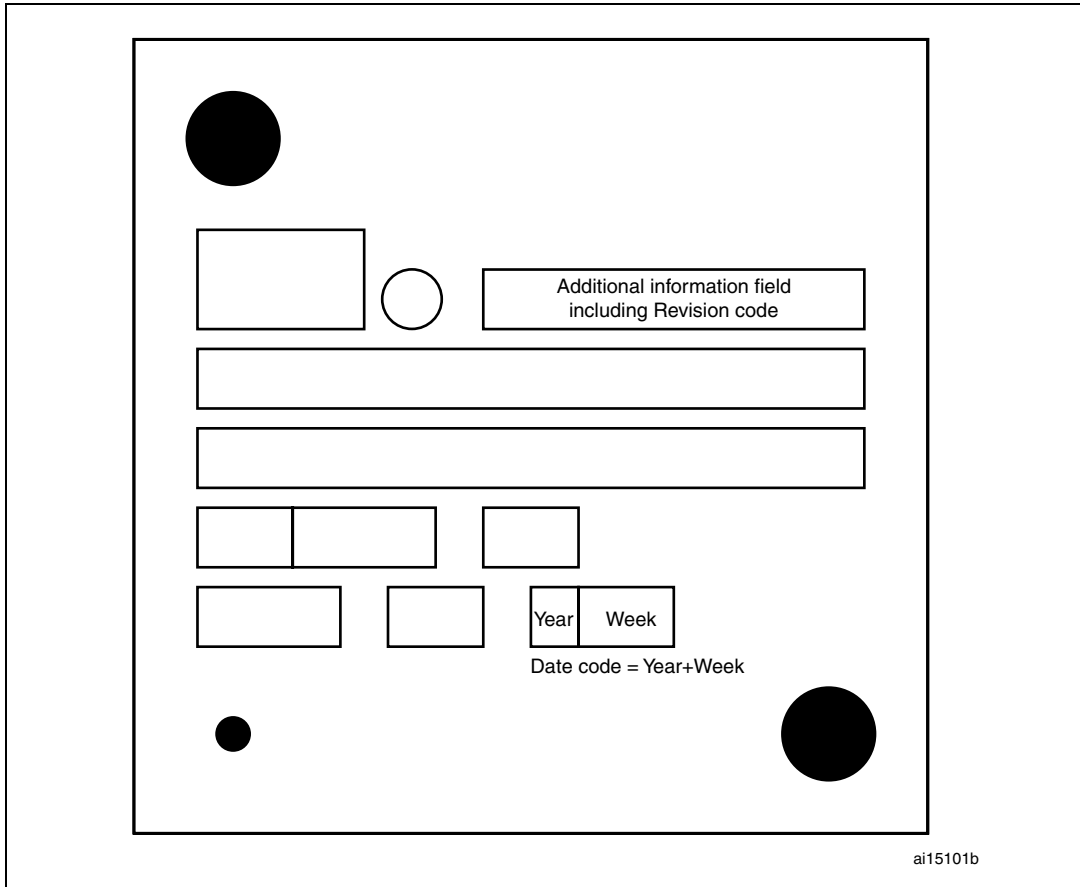
Figure 1. LQFP144 top package view

Figure 1, Figure 2 and Figure 3 show the marking compositions for the LQFP144, LQFP100 and LQFP64 packages, respectively. Only the Additional field containing the Revision code is shown.

2. Refer to [Appendix A: Revision code on device marking](#) for details on how to identify the Revision code on the different packages.
